# **Case Study – NE3 Window Replacement Lessons Learned and Energy Performance Impact**

Prepared by Frederico Martins de Barros, MAsc. candidate in Building Science BCIT

**Burnaby, British Columbia  
2016**

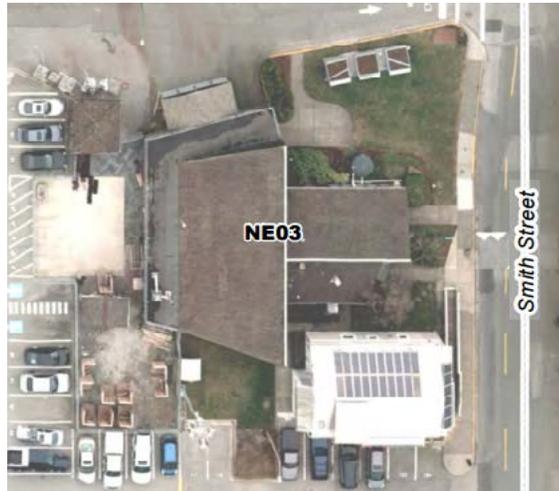
Figure 2.1 – Top view of NE3 – Centre for Architectural Ecology

NE3 – Centre for Architectural Ecology is located at 3700 Willingdon Avenue, BCIT Burnaby Campus. This 648 m<sup>2</sup> (6,975 ft<sup>2</sup>) wood-frame building was constructed on site in 1971 and since 2003 is the home to the Centre for Architectural Ecology. Nowadays, this research facility is dedicated to applied research and education under the direction of Dr. Maureen Connelly. When it comes to research areas, the centre is well-known to develop research in building acoustics, green roofs, and vegetated walls. Figure 2.1 shows the top view of the building.

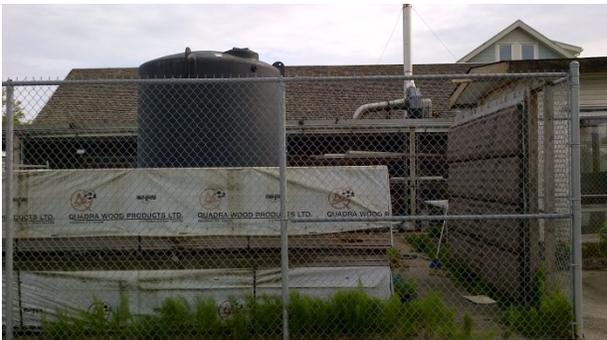
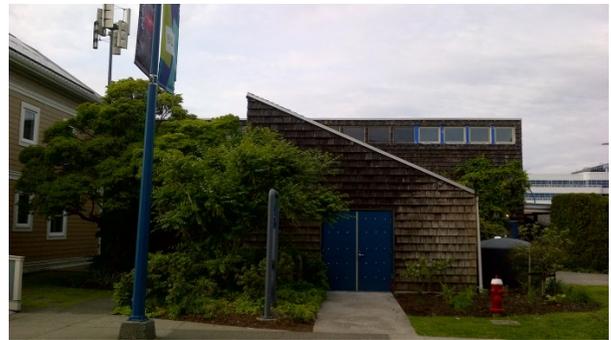
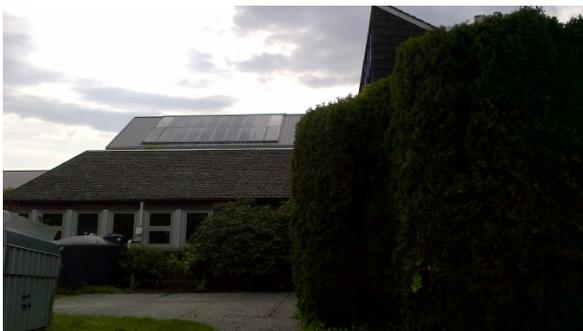
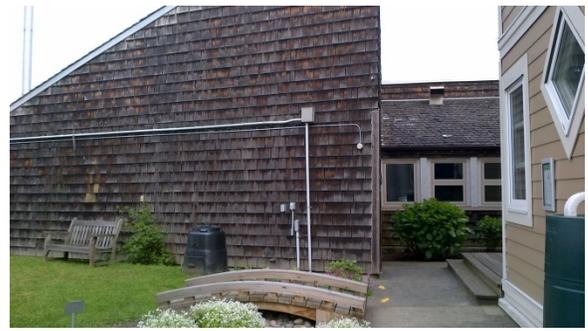
Figure 2.2 – NE3 elevations

Figure 2.2 presents the building elevations.

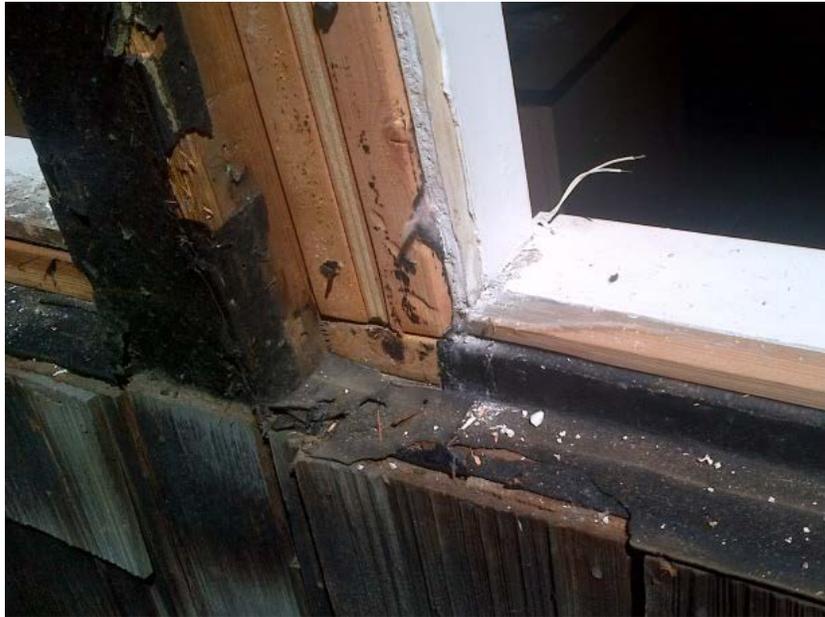
Figure 2.4 – Window frame and building paper

The thermal insulation, made of fiberglass batts, is positioned inside the wood frame wall cavity. In the outside surface of the envelope, building paper serves as water resistive barrier (WRB) and air barrier. It is important to mention that the continuity of the air barrier is sometimes compromised along the assembly. For example, the connections between the building and the single-pane windows without proper sealants generate a certain amount of air leakage through the frame. Further, the air barrier is not continuous to the door frame, gaps exist where shingles are missing, and the shingle cladding has not been sealed to the door frames.

The poor connection to the air barrier results in air leakage through the enclosure and excessive energy consumption. Due to the absence of sealants and poor connection to the air barrier, currently, there is also the potential for water ingress at the junction between the frame and cladding. Figure 2.4 presents, after the removal of the window, the connection between the building paper and the window frame. It is possible to attest the part of the building paper (air barrier) is compromised, therefore, during the installation of the new windows the building paper was substituted by spun bonded polyolefin (Tyvek).

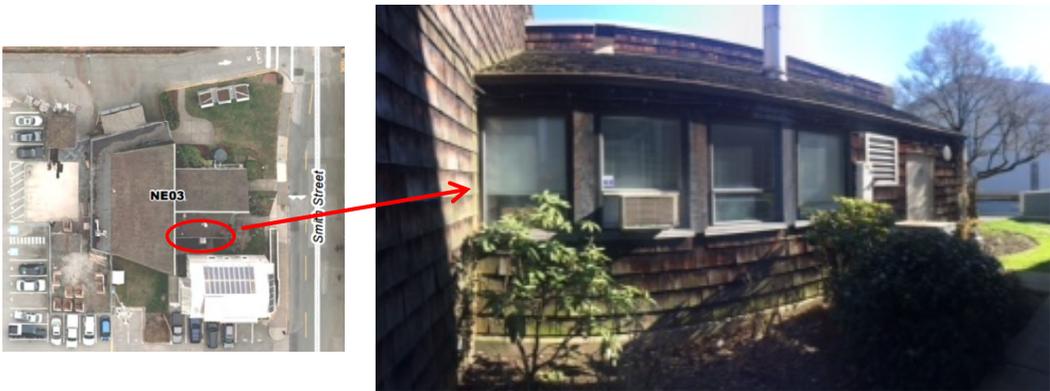
Figure 2.7 – West-facing windows

Figure 2.7 presents the 4 west-facing windows of NE3; its dimensions are also 4' 6'' (137 cm) of height by 3' (91 cm) of width.

Table 2.2 shows the properties and dimensions of the old and new west-facing windows.

West-facing windows	
	Previous window	New window (Centra)
Number of windows	4	
Window height (ft)	4.5	
Window width (ft)	3.0	
Frame material	Aluminum	Vinyl
Number of panes	2	2
Gap thickness (mm)	13	13
Gap glass fill	Air	Argon
Overall U-value (W/m <sup>2</sup> K)	3.7*	1.6
Solar heat gain coefficient (SHGC)	0.76*	0.30
Low-e coating	No	Yes
Visual transmittance (VT)	-	64%

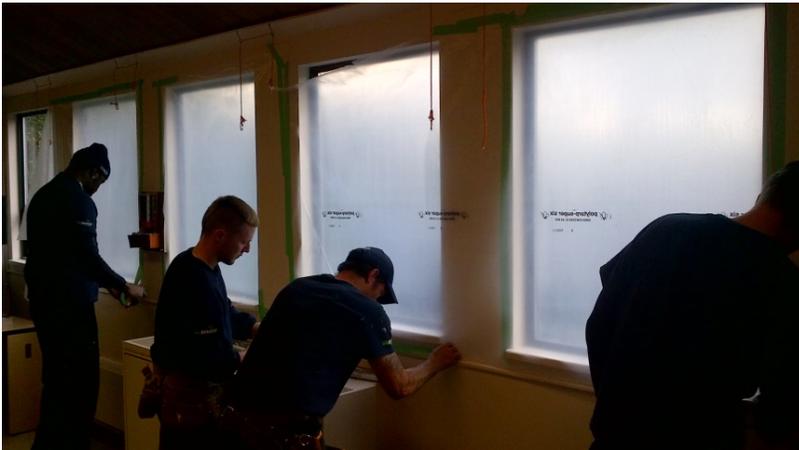
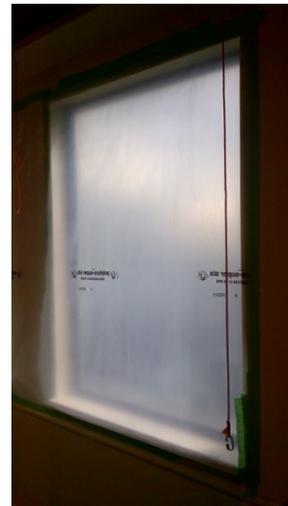
Figure 3.1 – Positioning 6 mil polyethylene before the windows removal

Common in the 1970's construction, NE3 building used asbestos containing mud for the interior walls. At present time, when the hazardous effects of exposure to asbestos are well known, special care is needed to deal with the materials. During the implementation of the new windows, all the specifications prescribed by WorkSafe BC to deal with this kind of materials were respected and a removal/installation procedure was developed for the installation team to follow. A Notice of Project (NOP) was also submitted to WorkSafe BC. One example of the numerous steps included in the procedure is illustrated in Figure 3.1. Before the removal of the old windows, a layer of 6 mil polyethylene was sealed in the interior part. Figure 3.1 present this procedure and how windows were sealed.

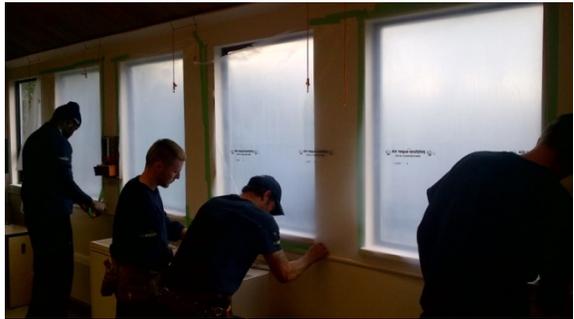
<p><b>Step 1:</b> Position a 6 mil polyethylene film in the interior wall, avoiding exposure to the asbestos in the interior wall board.</p>

A photograph showing several workers in a room installing large sheets of white polyethylene film over window openings. The workers are wearing dark clothing and are focused on their task.
<p><b>Step 2:</b> Take off the old window trim to remove the window entirely. Again, the removal procedure developed addressed the hazmat risk associated to this phase.</p>

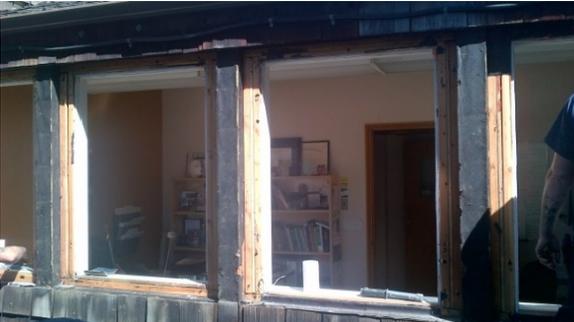
A photograph showing workers in a room removing window trim. The window frames are exposed, and the workers are using tools to carefully remove the trim pieces.

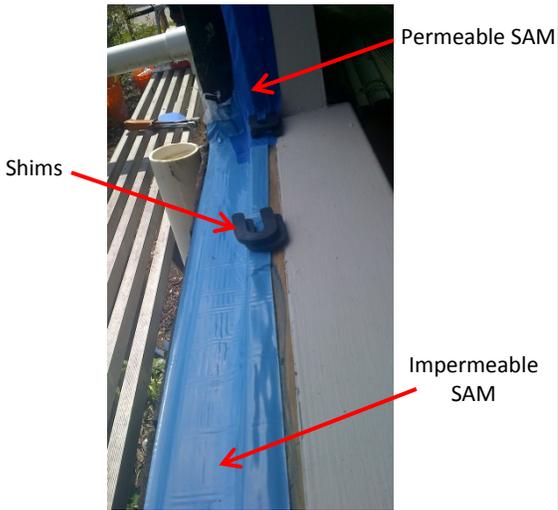
<p><b>Step 3:</b> Put impermeable self-adhered membrane (SAM) in the window sill and corners. Permeable self-adhered membrane (SAM) is used for the window jambs. The shims are positioned and the new window is installed over it.</p>

A close-up photograph of a window sill being prepared for installation. A blue impermeable self-adhered membrane (SAM) is applied to the sill and corners. A permeable SAM is applied to the window jambs. Shims are positioned on the sill. Red arrows point to the labels: 'Permeable SAM' at the top, 'Shims' on the left, and 'Impermeable SAM' at the bottom right.
---	---

The impermeable SAM in the window sill is a common practice to avoid water infiltration; it works as a water resistive barrier (WRB). With similar function, the permeable SAM is

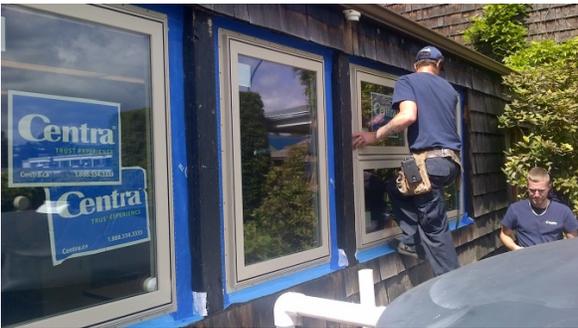
<p><b>Phase 4:</b> The windows are installed and properly sealed.</p>

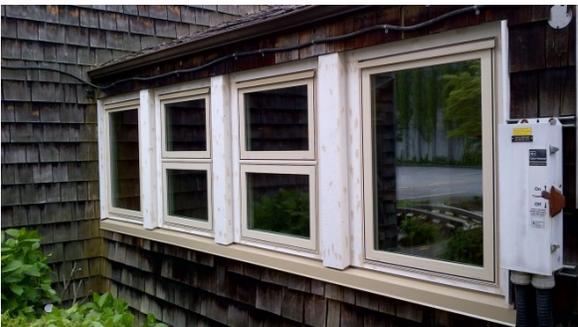
<p><b>Phase 5:</b> Window trim and cladding are positioned.</p>

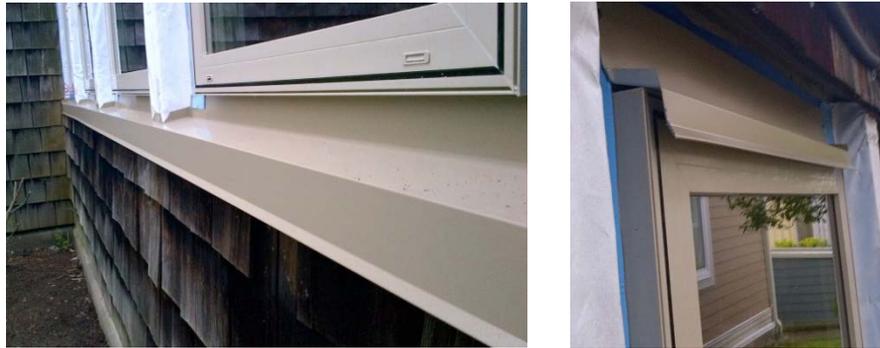
Figure 4.1 – Window flashing

positioned in the window jambs. After the glazing is installed and sealed, the window flashing is placed over and below the window. The flashings work as a water shedding surface (WSS) and protect/relieve the window jamb and sill of the rain water loads (see figure 4.1).
